# **Regina Planning Commission**

**Public Agenda  
Regina Planning Commission  
Thursday, November 13, 2025**

PROJECT: **CREDIT FONCIER BUILDING**  
SERVICE: **HERITAGE REVIEW AND ASSESSMENT**  
ADDRESS: **2184 12TH AVENUE, REGINA**  
DATE: **August 2025**

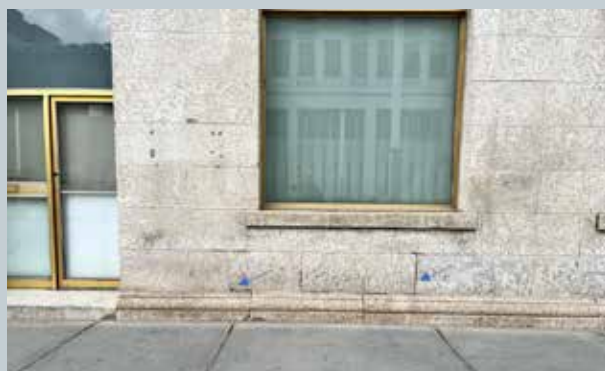
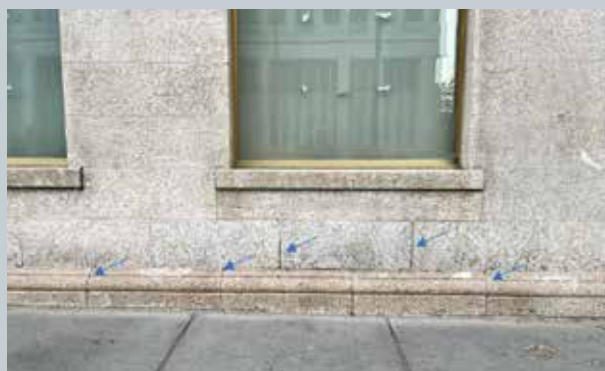
Cracks observed in the mortar joints and stones on the west elevation.

- West and South (Tyndall stone): Localized cracking was observed in both stone and mortar joints, along with moisture staining at lower courses, consistent with capillary wicking.
- Southwest entrance: Cracks were present in surrounding mortar joints.
- East and North (brick masonry): Severe mortar joint erosion and widespread cracking were noted, including deterioration at the parapets.

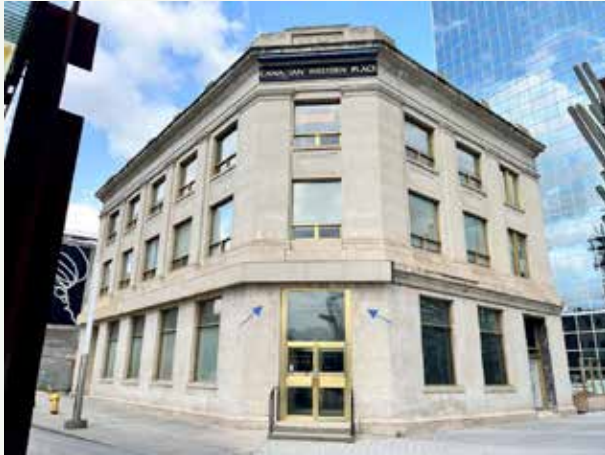
*Cracks observed in the mortar joints and stones on the west elevation.*

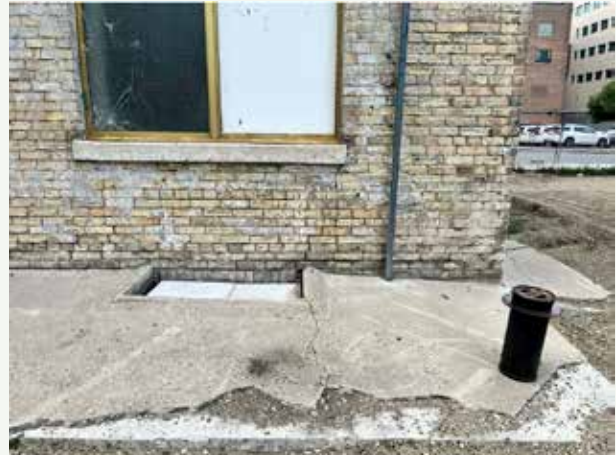
*Eroded mortar joints, deteriorated brick masonry, and cracks from differential movement*

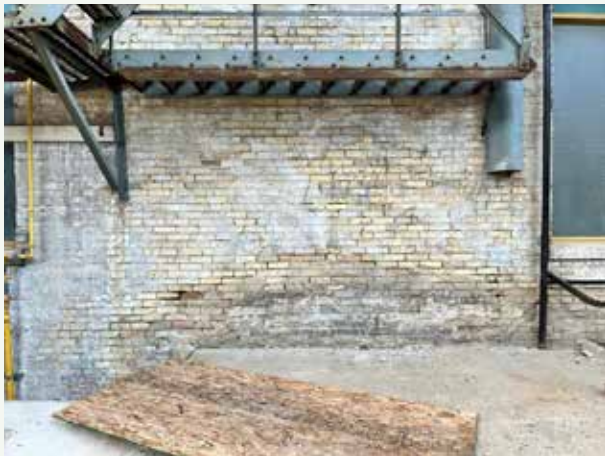
*Eroded mortar joints on the east elevation*

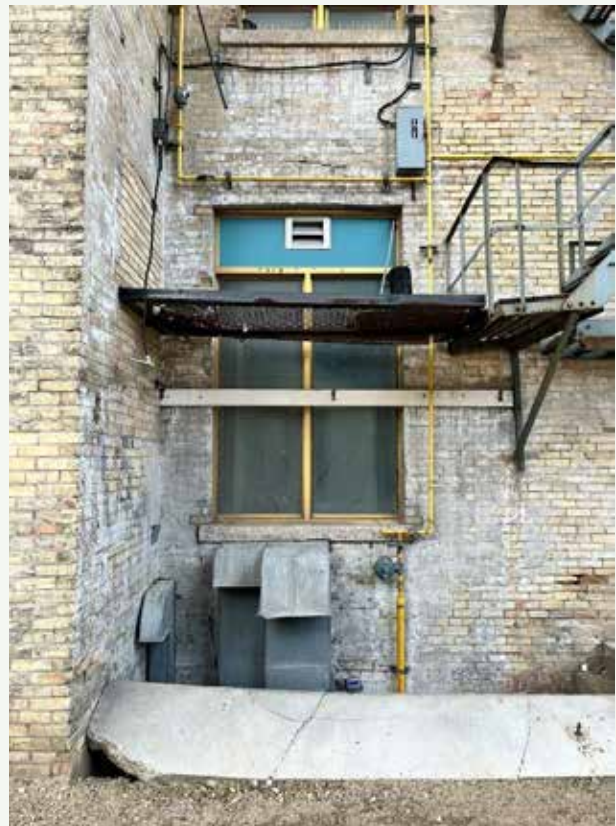
*Uneven sidewalk above the retaining wall that had failed*

- Basement stairwell (east side): Retaining wall failure had caused inward bowing and displacement of the adjacent walkway; this condition was identified as a safety hazard and has since been infilled.
- Basement: The floor slab exhibited heaving, scaling, and efflorescence. Moisture infiltration was evident at brick foundation walls, with areas of surface spalling and material loss.
- Upper floors: The main, second, and third floor slabs showed no signs of structural distress, though minor unevenness may reflect long-term settlement.
- Roof: A hole was observed adjacent to a roof drain, indicating past water ingress.

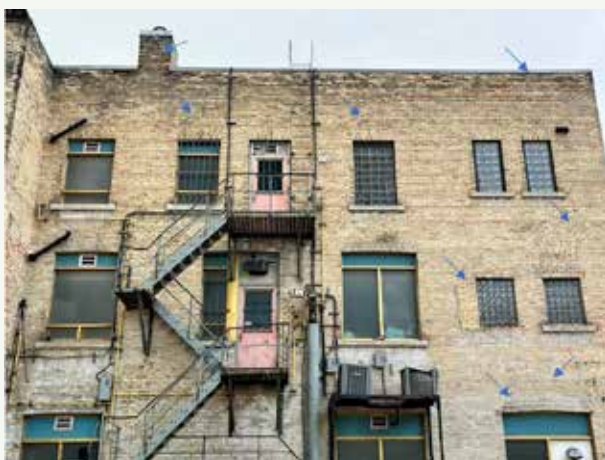
*Cracks observed throughout the wall and eroded mortar joints at the parapet*

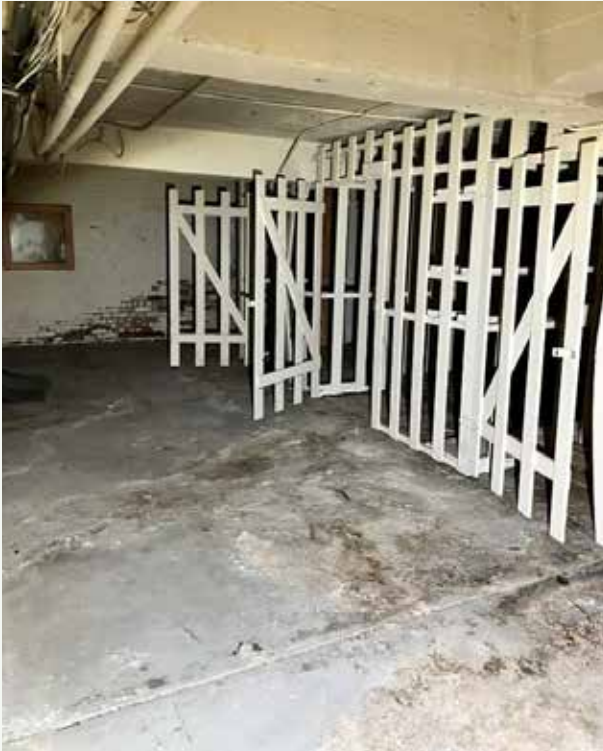
*Heaved floor slab in the basement with cracks and efflorescence.*

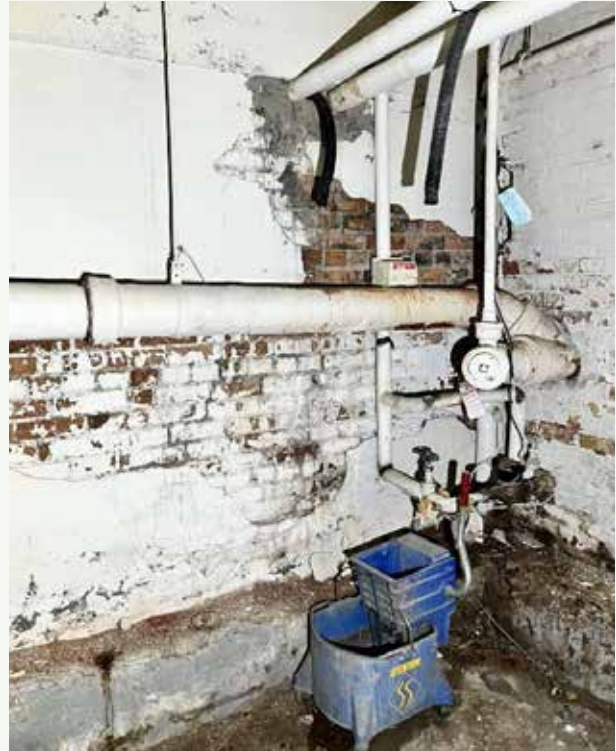
*Views of the foundation wall where moisture had caused the surface to fail*

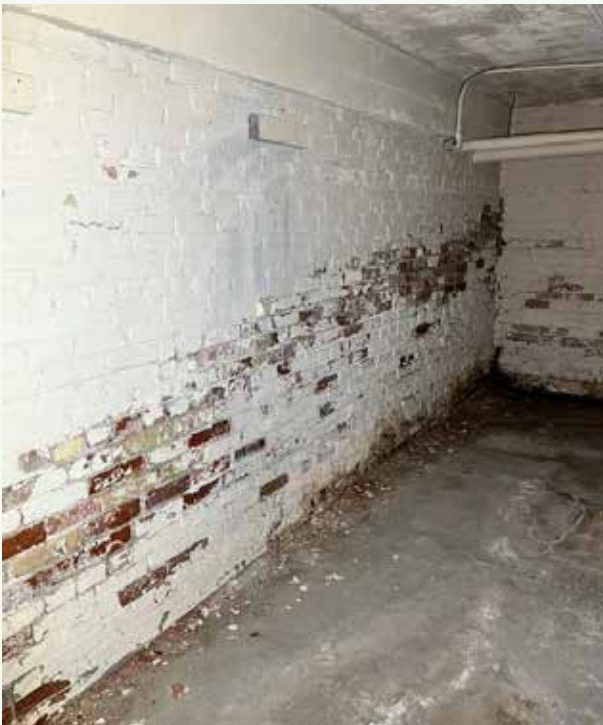
*View of the foundation wall where moisture had caused the surface to fail*

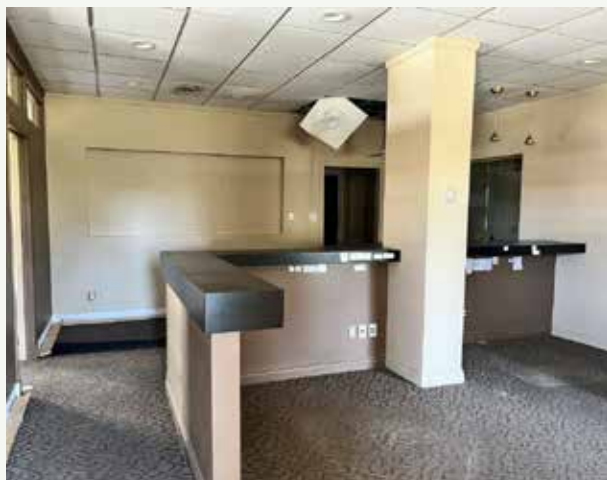
*View of the Third Floor, also showing the location of the water leak*

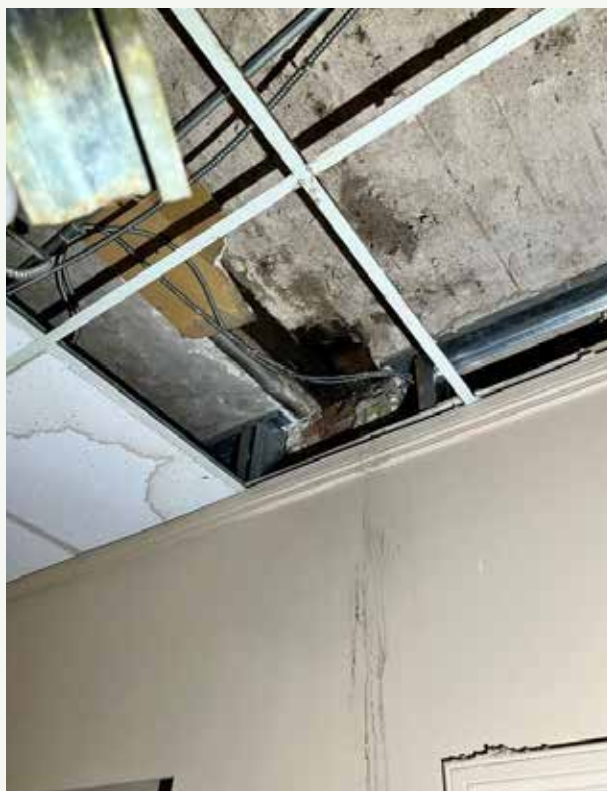
*Within the wood roof structure, a metal pipe was observed where the leaks appeared to have originated.*

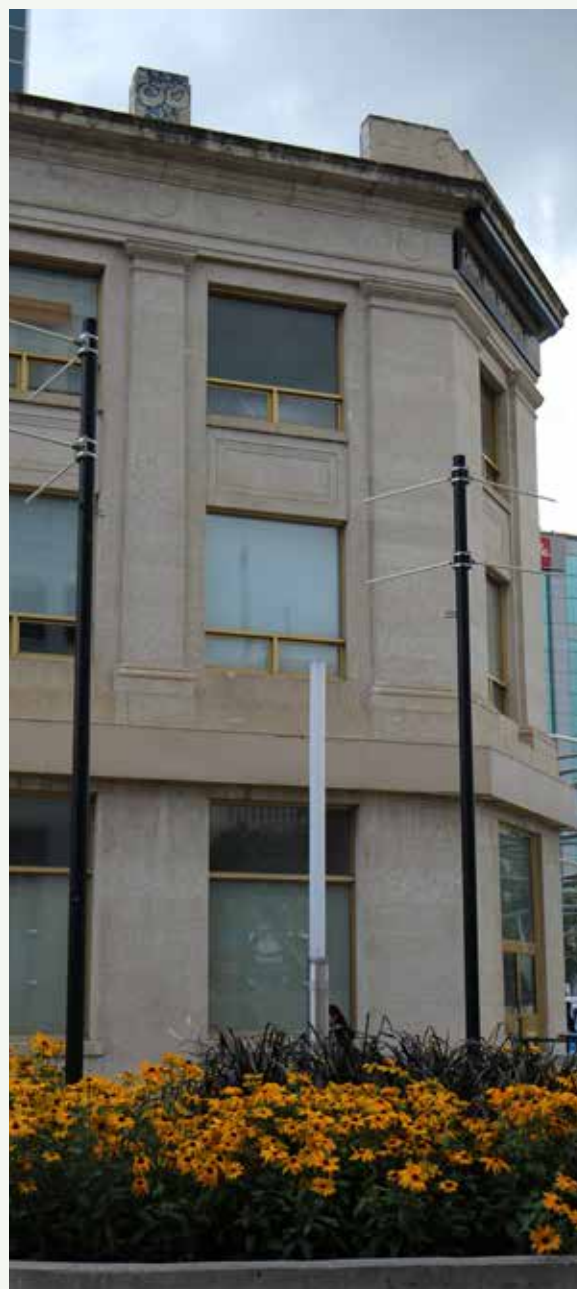
The Credit Foncier Building features a flat roof, characteristic of Chicago School design architecture. The skeletal steel-frame construction is articulated externally through the flat roof form and the regularity of the façades. According to the 1980 Heritage Evaluation Form, the functional roof assembly was constructed as a tar and gravel system, typical of the period of construction.

*Detail of the Credit Foncier Building roofline, showing the flat roof assembly, projecting cornice, and parapet, as viewed from Cornwall Street*

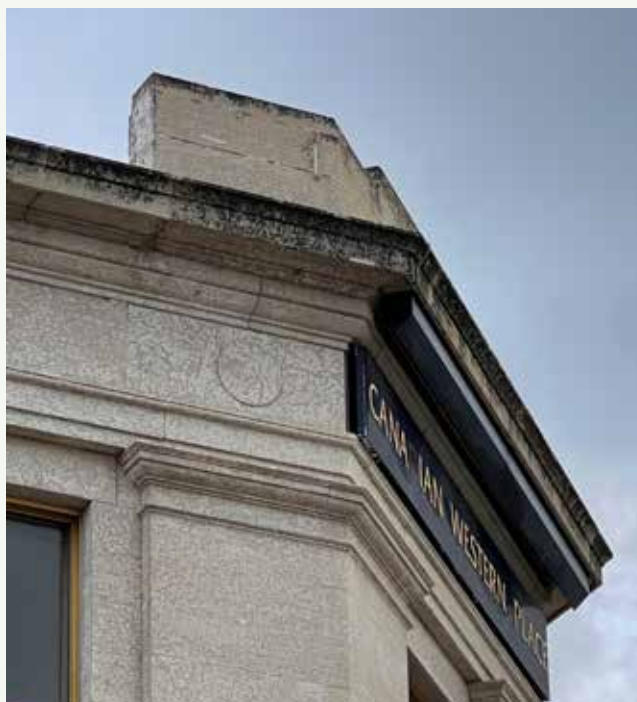
As viewed from street level, the roof cornice appears to be in fair condition, with evidence of organic growth, staining, and localized cracking of the Tyndall stone and mortar joints, as noted in the structural condition assessment. A structural review and exploratory investigation of attachment conditions will be required to confirm its soundness and to determine whether additional reinforcement is necessary.

*Credit Foncier Building, detail of the projecting Tyndall stone roof cornice and partial parapet, as viewed from the corner of Cornwall Street and 12th Avenue*

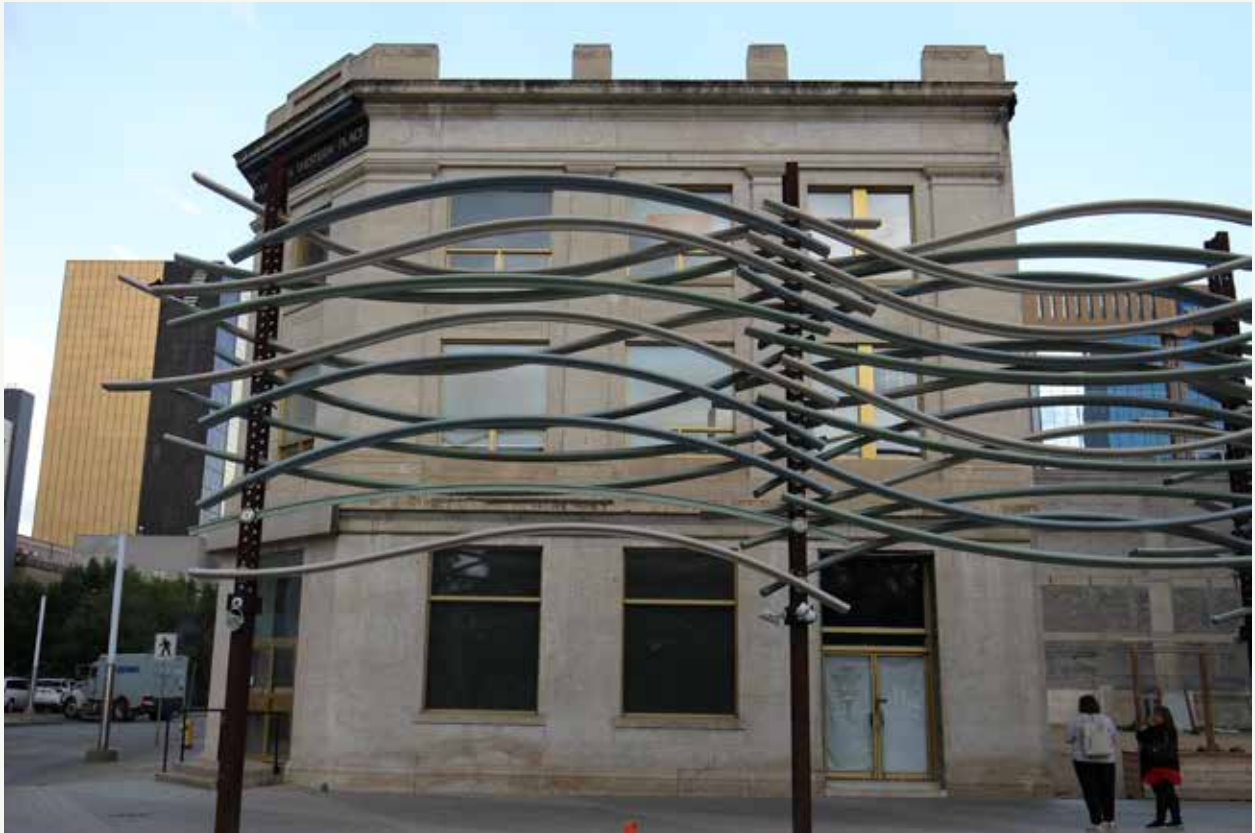
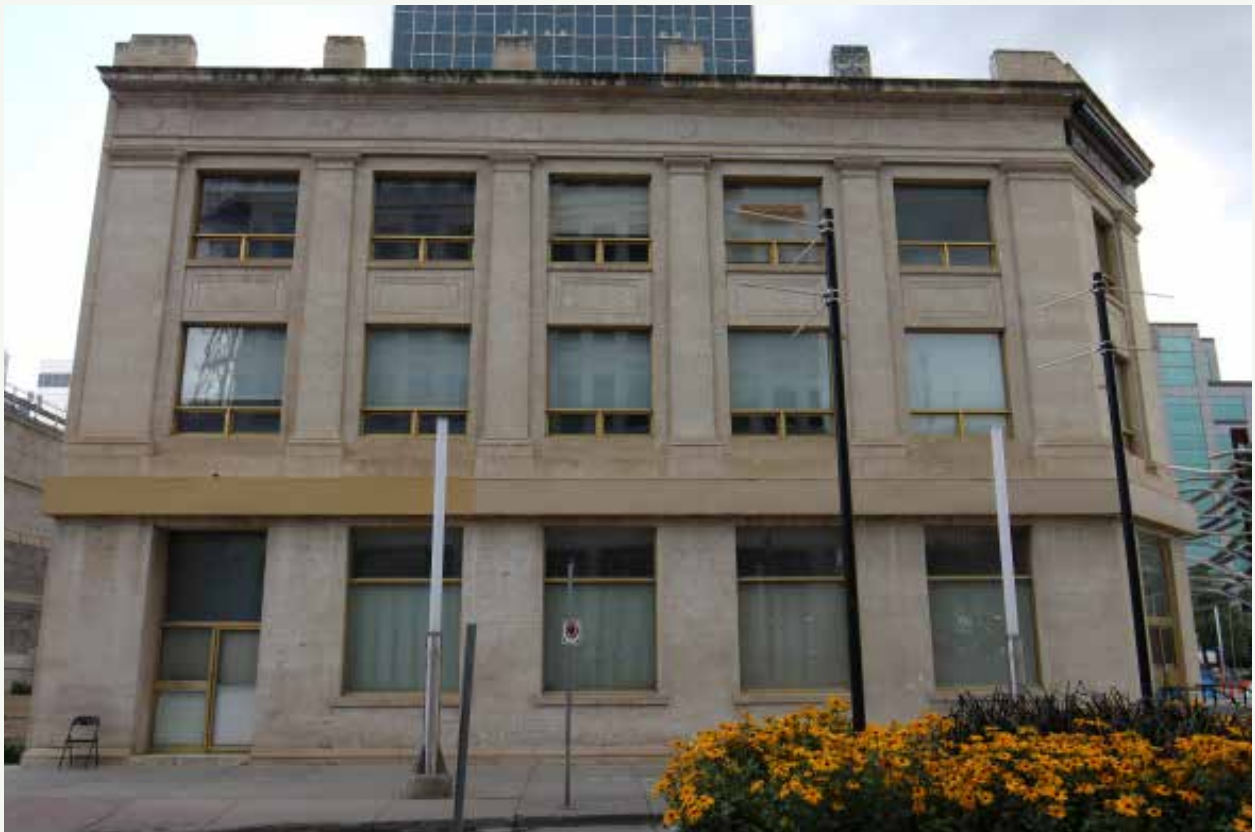
*West street façade along Cornwall Street showcasing Tyndall stone construction*

- Repair localized cracking and surface spalling with compatible patching materials; replace only where deterioration is severe and repair is not feasible.
- Where replacement is required, use new Tyndall stone sourced or tooled to match the original in type, colour, finish, and tooling.
- Protect original architectural detailing, including pilasters, spandrel panels, cornices, and quoins, from alteration or removal.
- Monitor masonry conditions, with particular attention to moisture staining and mortar erosion at base courses, as part of cyclical maintenance, addressing localized deterioration before it accelerates.

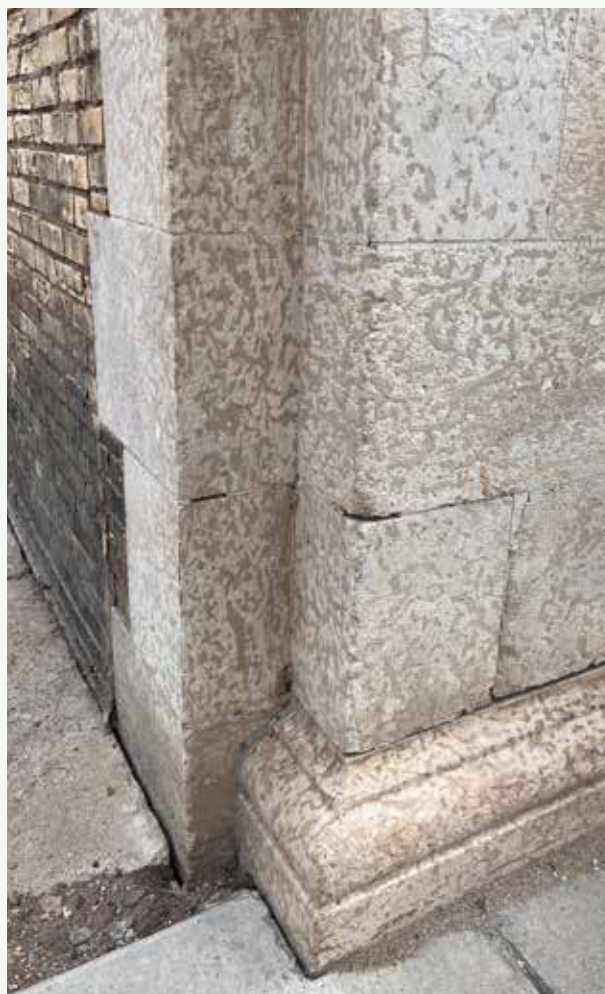
*Corner condition showing Tyndall stone base courses and quoining detail, with adjacent brick masonry at return wall*

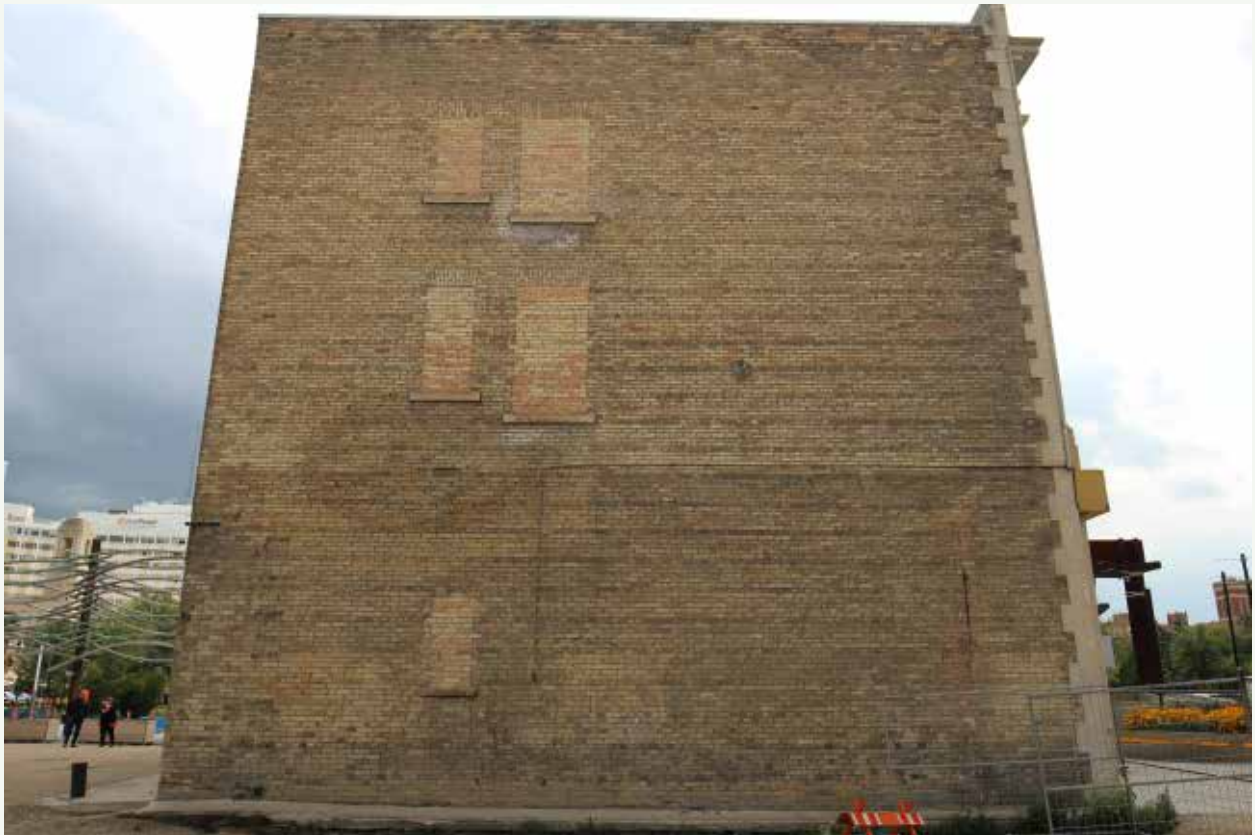
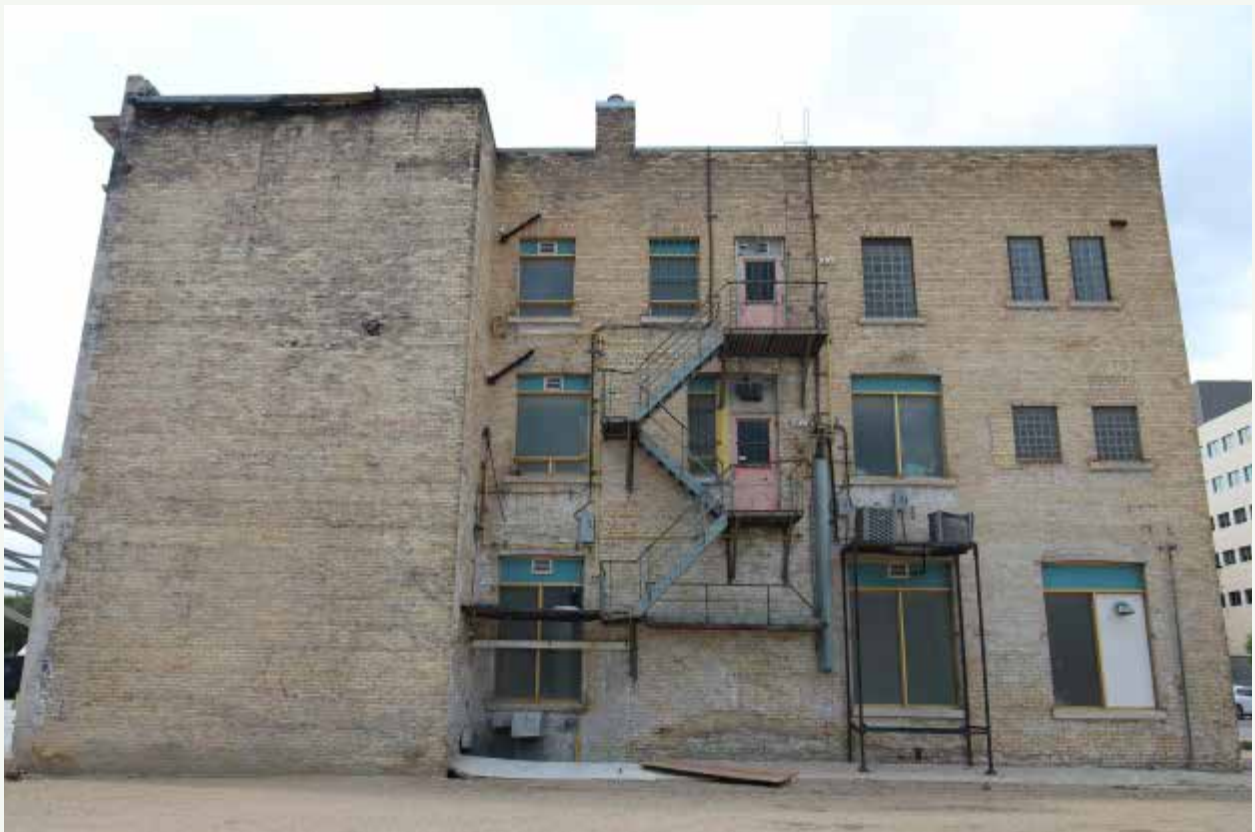
*East brick façade with altered openings and fire escape*

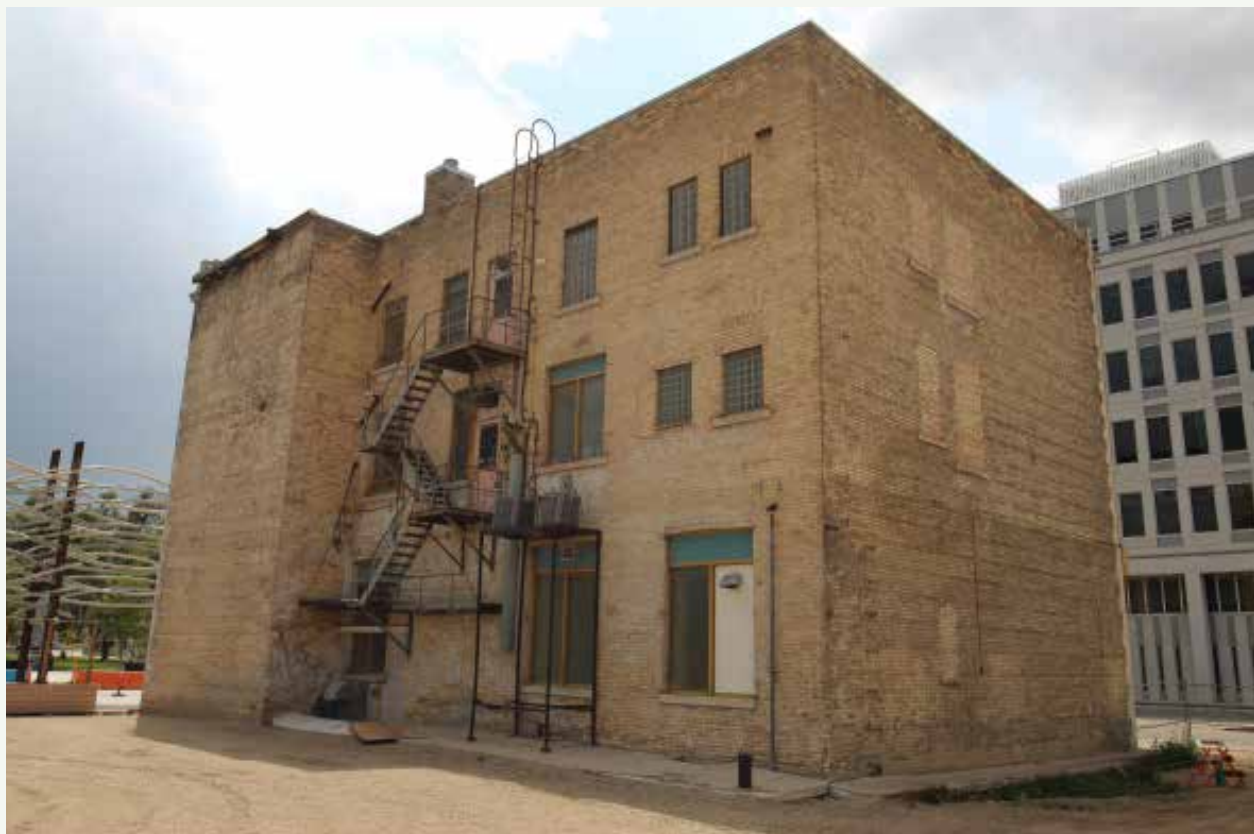
Rear brick façades showing blocked openings, fire escape, and mounted mechanical units

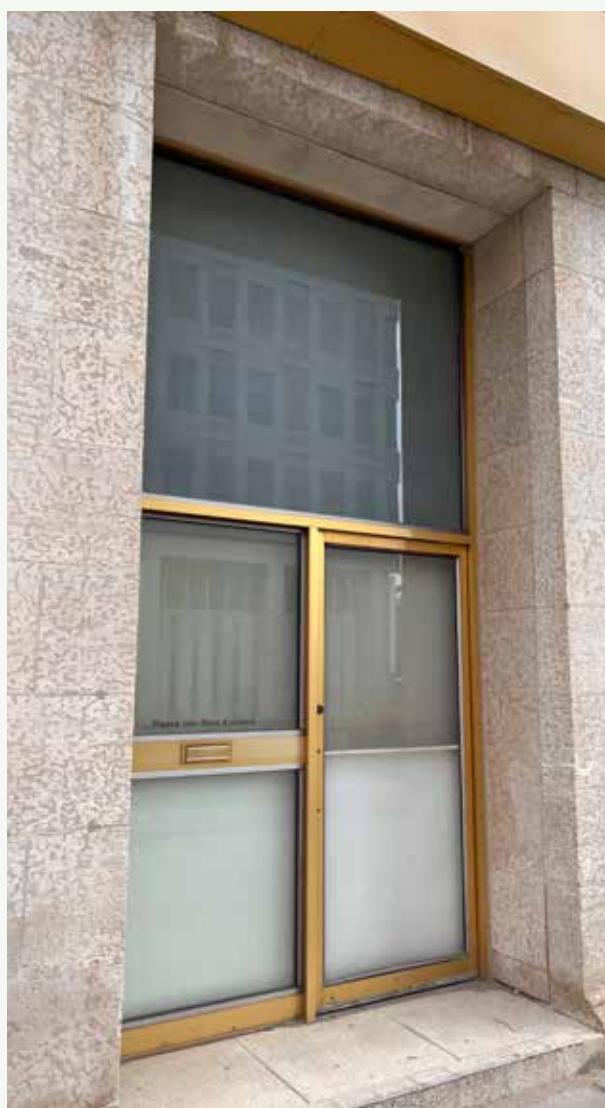
*Original masonry opening at the north end of west façade facing Cornwall Street, with modern door and transom inserts*

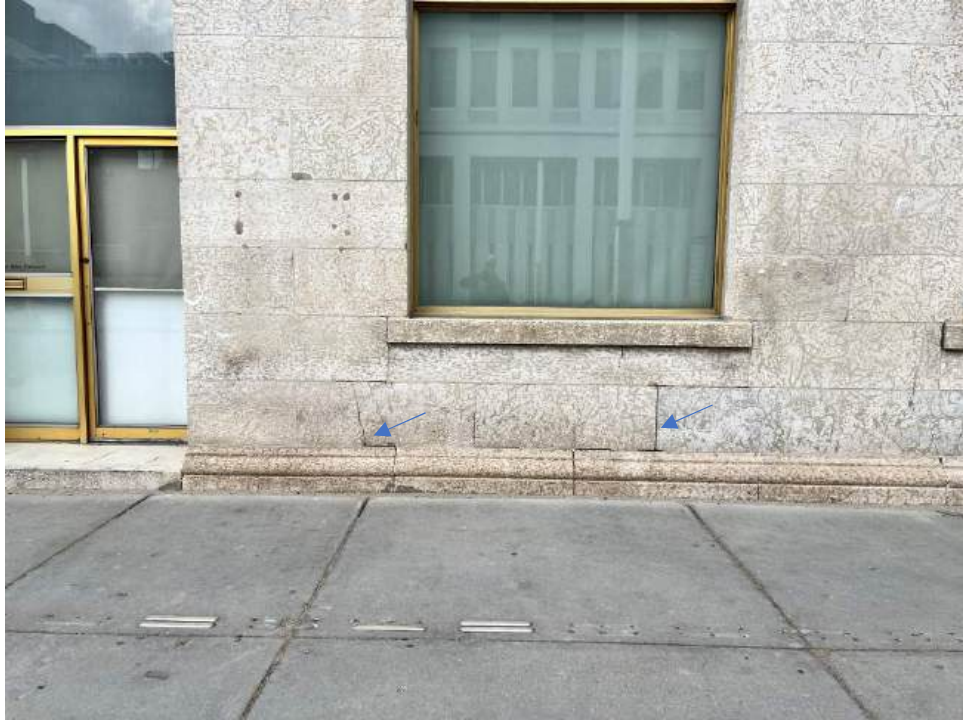
Photo 1: Cracks observed in the mortar joints and stones on the west elevation

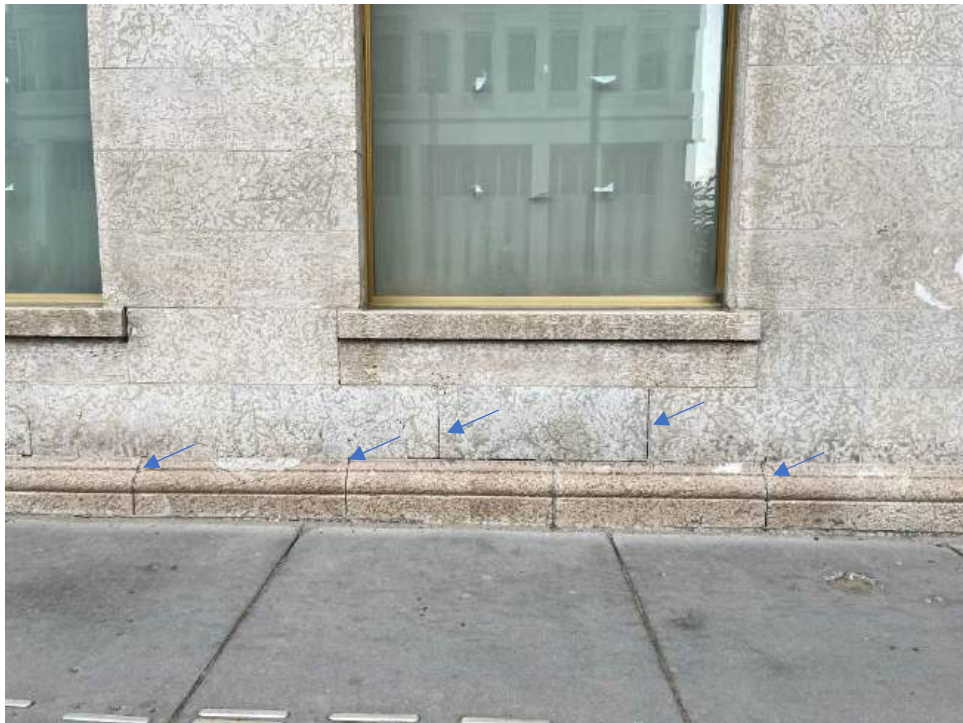
Photo 2: Cracks observed in the mortar joints and stones on the west elevation

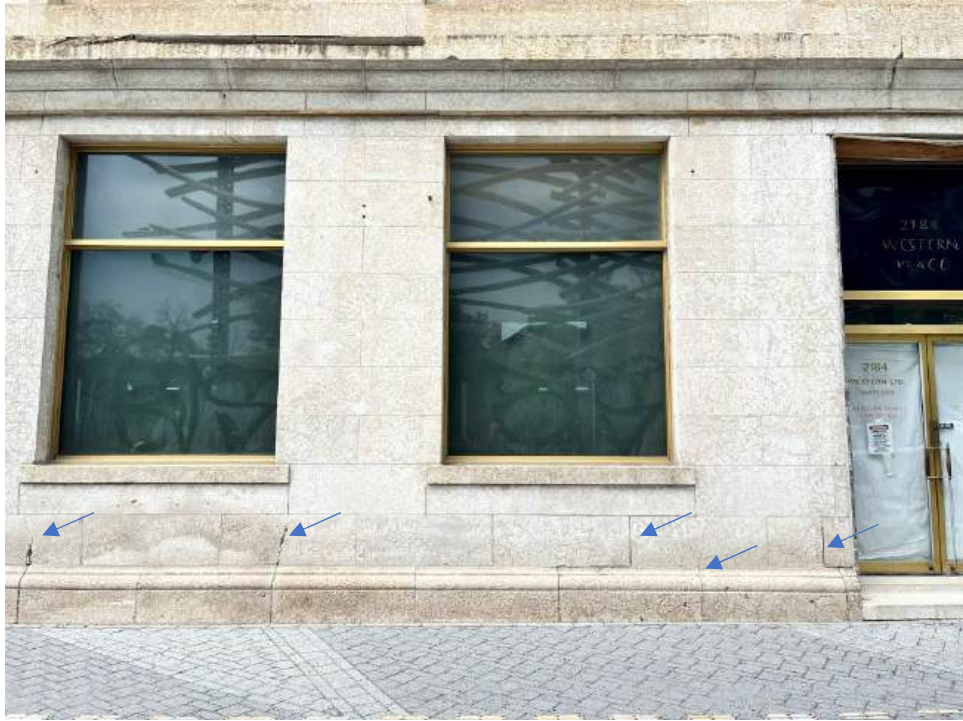
Photo 3: Cracks observed in the mortar joints and stones on the south elevation

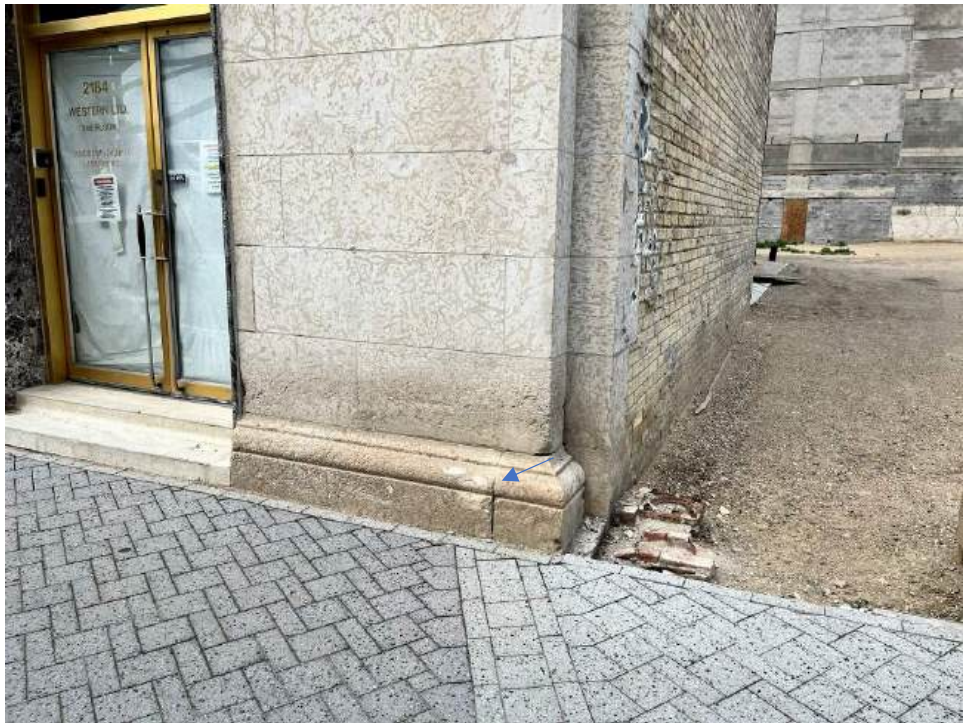
Photo 4: Cracks observed in the mortar joints and discoloration of the stone from moisture

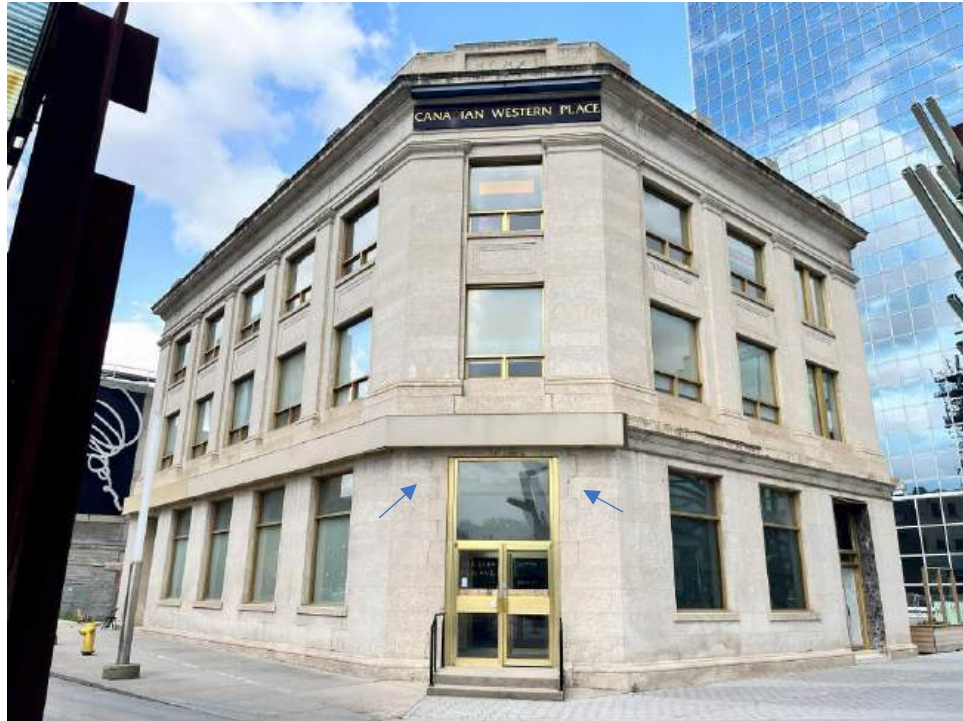
Photo 5: Cracks in the mortar joints around the southwest entrance

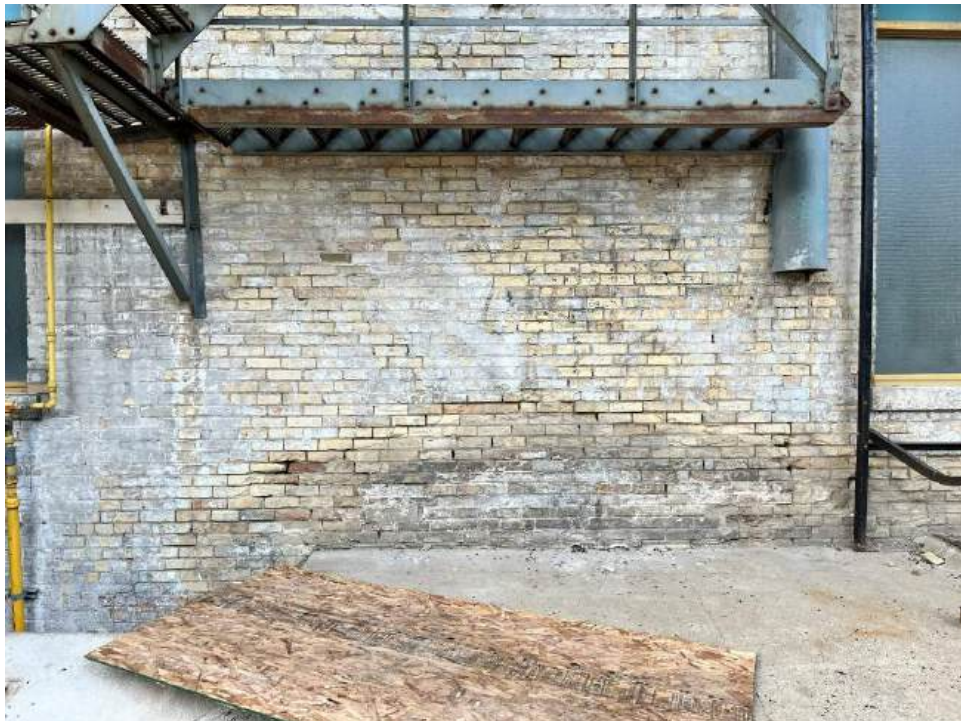
Photo 8: Eroded mortar joints on the east elevation

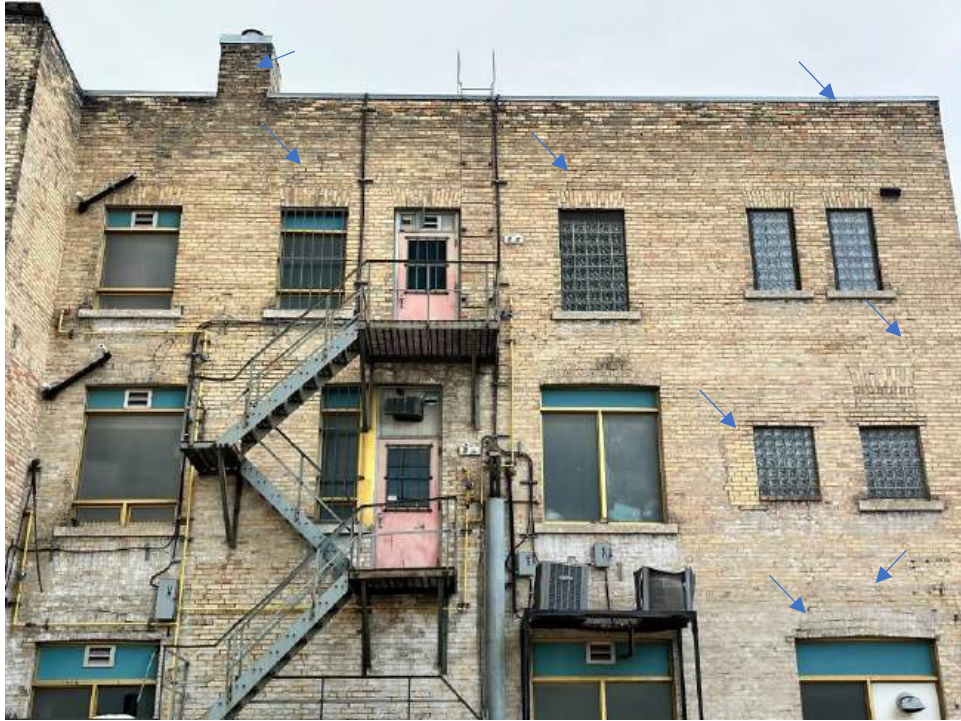
Photo 9: Cracks observed throughout the wall and eroded mortar joints the parapet

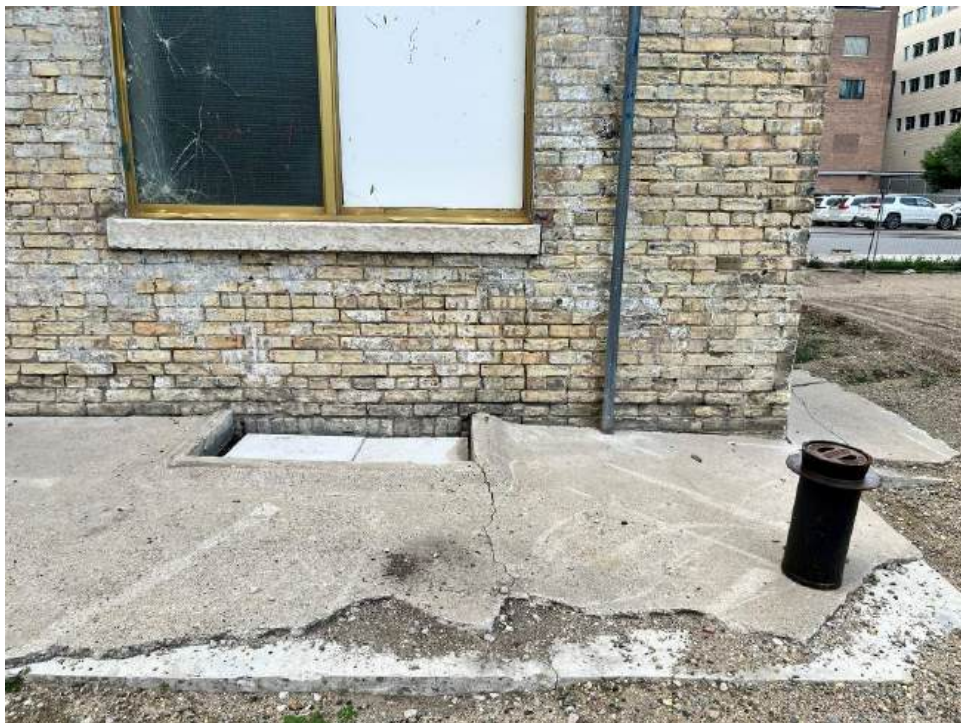
Photo 10: Eroded mortar joints, deteriorated brick masonry, and cracks from differential movement

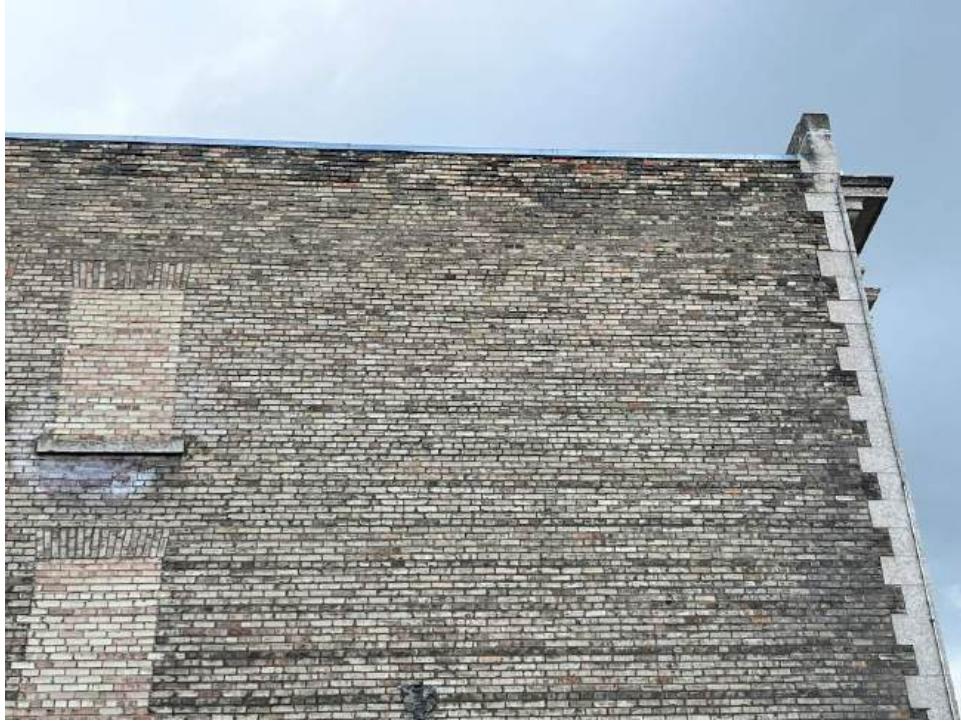
Photo 13: Partial elevation of the north side of the building where mortar joints have eroded at the parapet

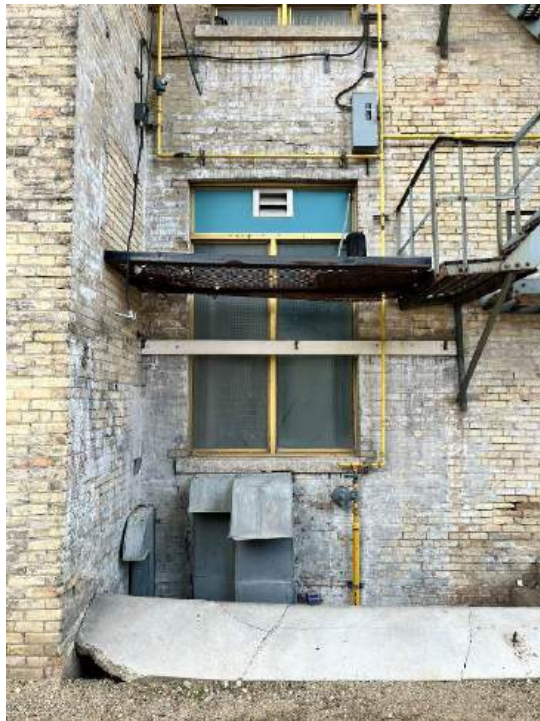
Photo 14: Uneven sidewalk above the retaining wall that had failed

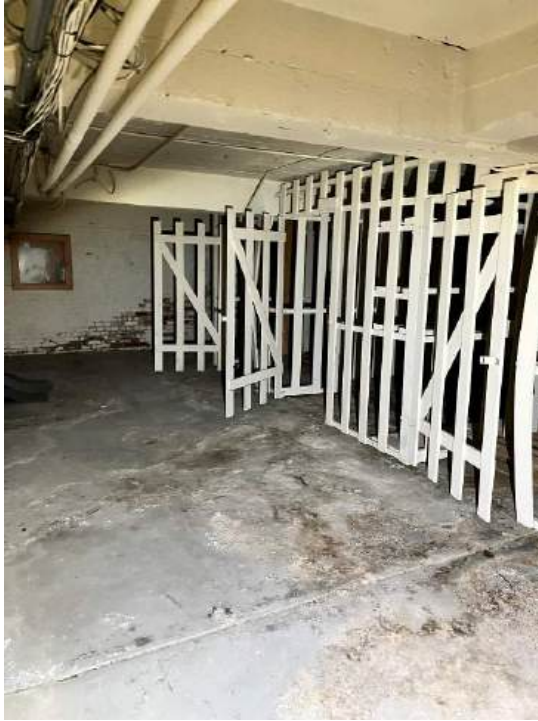
Photo 15: Heaved floor slab in the basement with cracks and efflorescence. Typical slab and beam construction could also be observed in the basement.

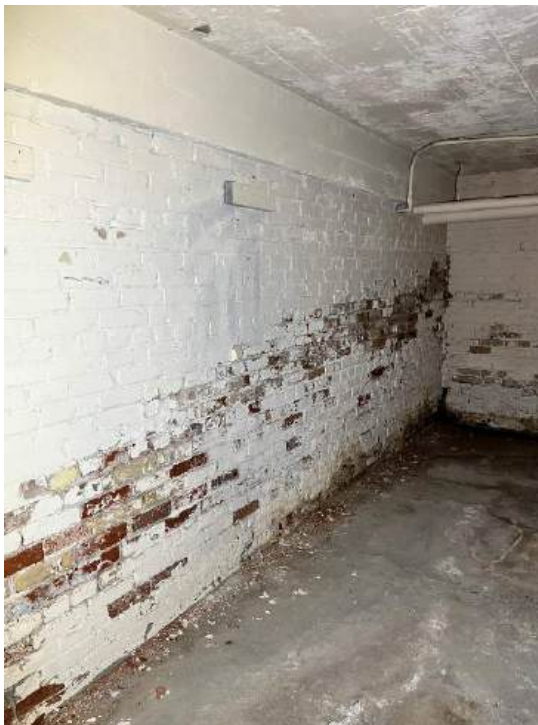
Photo 16: View of the foundation wall where moisture had caused the surface to fail

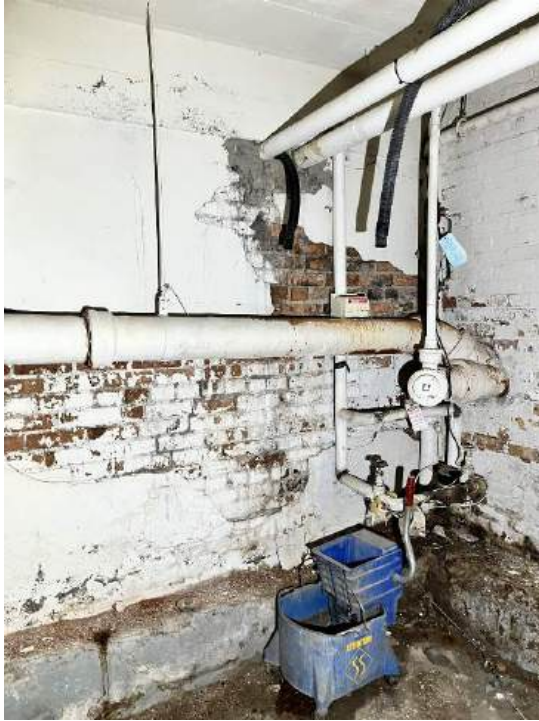
Photo 17: View of the foundation wall where moisture had caused the surface to fail

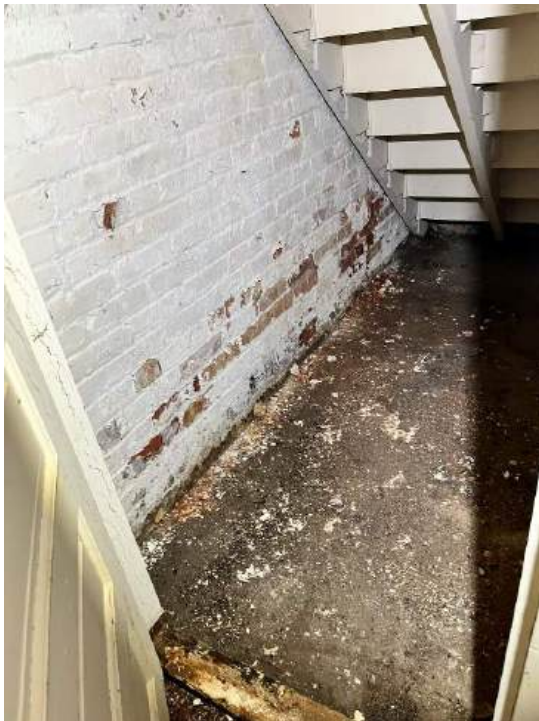
Photo 18: View of the foundation wall where moisture had caused the surface to fail

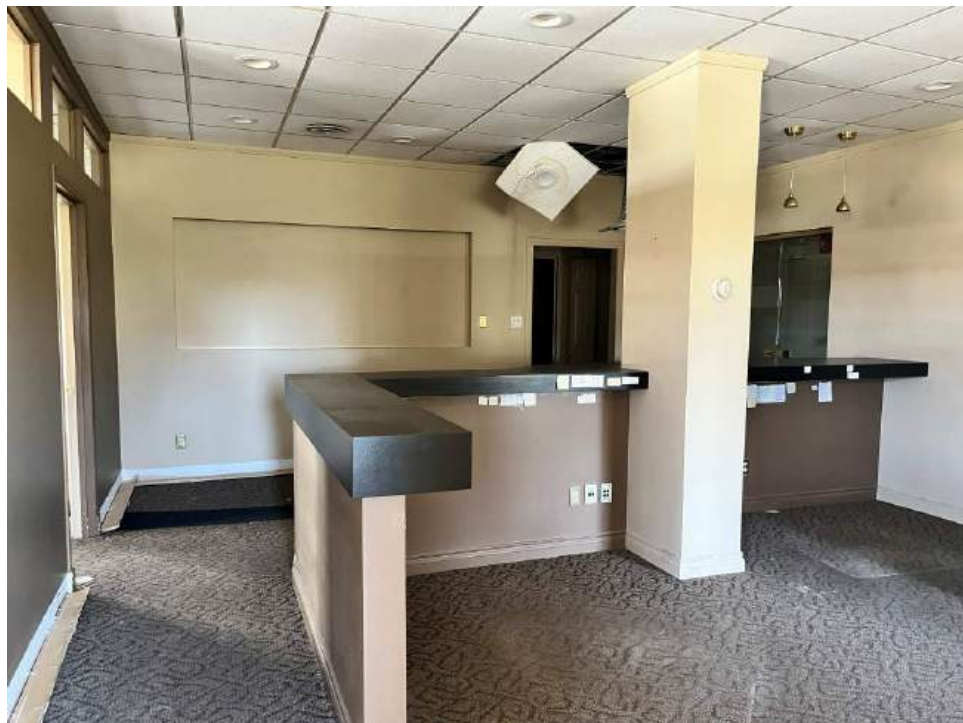
Photo 23: View of the Third Floor, also showing the location of the water leak

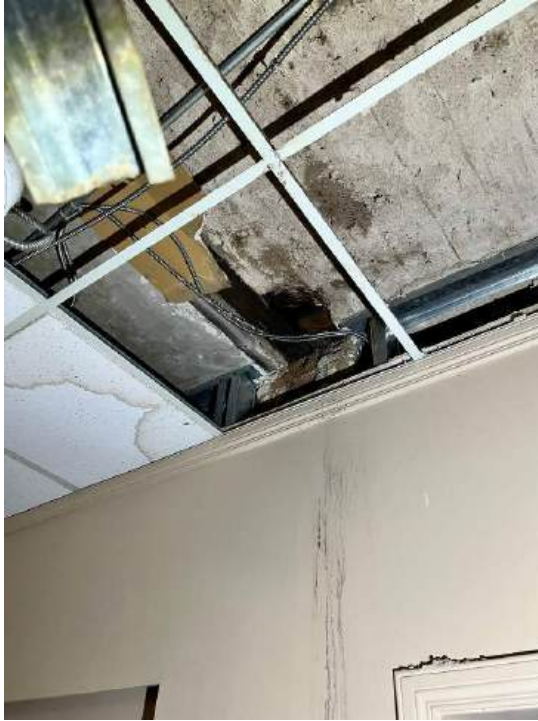
Photo 24: Within the wood roof structure, a metal pipe was observed where the leaks appeared to have originated.
